SEQUENTIAL EXCAVATION METHOD TUNNELLING IN WEAK SANDSTONE USING INNOVATIVE METHODS

ABSTRACT: The A3 Hindhead road improvement scheme in Surrey, UK includes 1.8km of twin bore tunnels excavated using the sequential excavation method. This paper describes the design and construction of the tunnels, focusing on the management of risk during construction. Two categories of construction risk are identified: construction project risk and health and safety risk. Systems have been put in place at A3 Hindhead to deal with both of these types of risk and the systems are described. The paper concludes by listing the principle factors in making the project a success, including personnel and design matters.

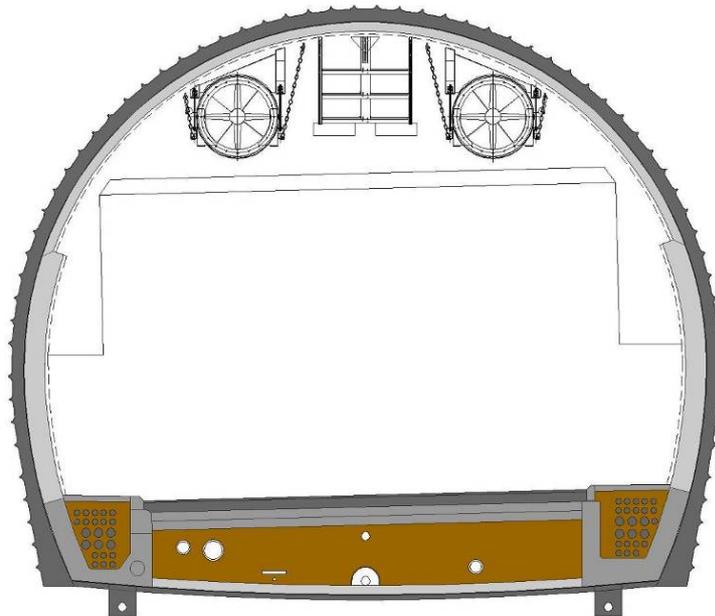
Figure 1: Tunnel General Arrangement

The tunnels incorporate a 7.3m wide carriageway with a 5.03m high traffic gauge and 1.2m wide verges on either side. Ground support comprises a 200mm thick sprayed concrete permanent primary lining. A secondary lining of; cast in-situ sidewalls typically 340mm thick and, sprayed concrete secondary crown lining of 150mm thickness was designed to support hydrostatic loading and internal M&E fixtures only (see figure 1). Interconnecting cross passages are located at nominal 100m centres principally to facilitate movement of pedestrians between tunnels in case of emergency. Emergency niches are provided midway between cross passages to provide a communications refuge for passengers in difficulty, connecting directly with the tunnel authorities.

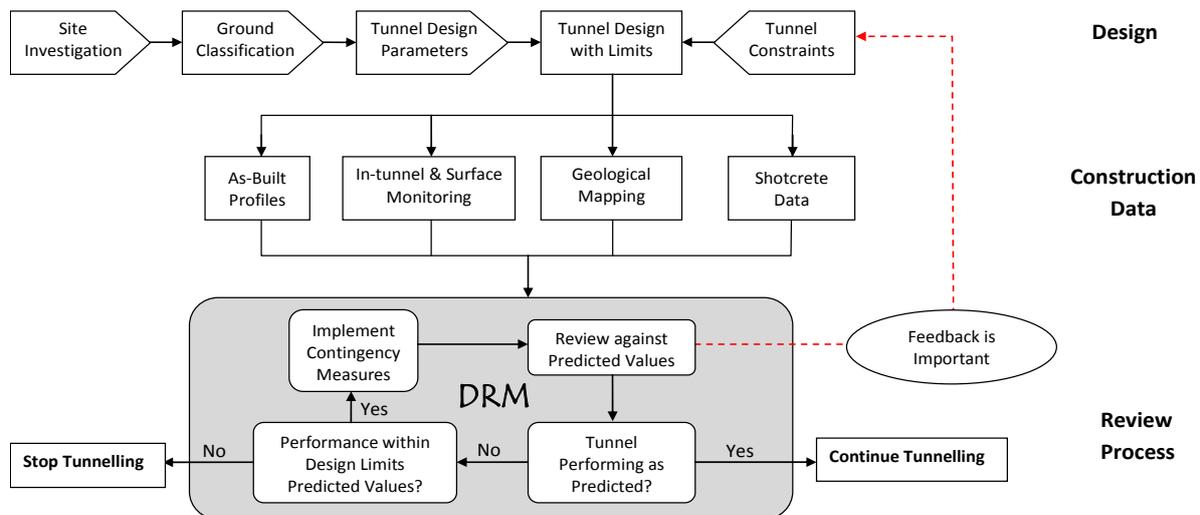
Figure 2 – DRM process map

Management of the construction project risk was achieved through Daily Review Meetings (DRMs) attended by competent and experienced personnel charged with selecting the most appropriate course of construction action going forward. The purpose of the DRM was to check the performance of the constructed tunnel against real time data collected during the previous 24 hrs and trend data. The DRM process is shown schematically in Figure 2. The requirement to hold DRMs was written into the contract specification. Data reviewed included: tunnel settlement and convergence, surface settlement, geological face logs, probing records, early age and 7 & 28 day sprayed concrete strength and quality, environmental monitoring and tunnel inspections.

The product of the DRM was the Required Excavation and Support Sheet (RESS). A RESS was produced daily for each face and was effectively a ‘permit to dig’ (i.e. no excavation was permitted without a valid RESS). Each RESS was signed at the DRM by the Contractor, Designer and an Independent Engineer (as requested by the Contractor to ensure impartiality). This procedure ensured that the contract parties carried out a daily review of the real time data to confirm that the chosen lining type and additional measures adopted were performing correctly and were compatible with current and expected ground conditions.

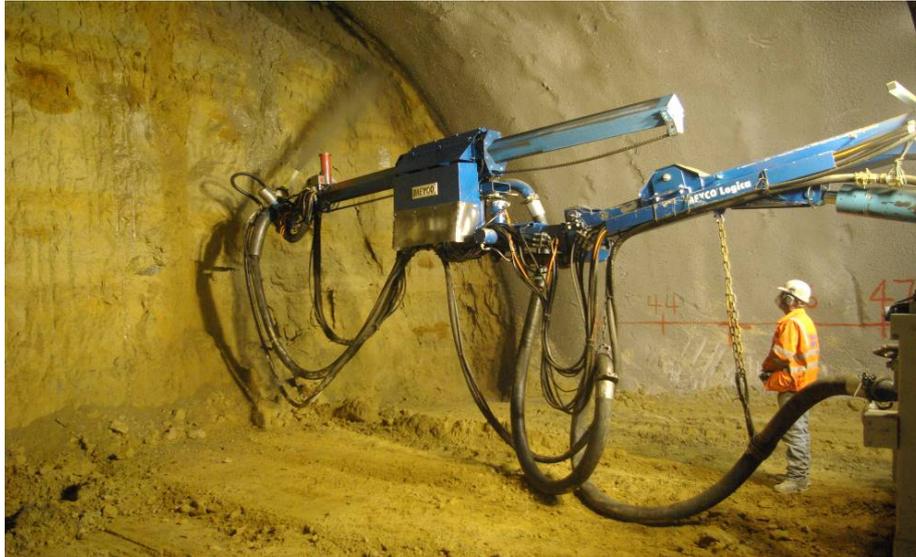
Figure 3 – Primary Lining Application

The risk of injury to personnel within the tunnel was mitigated principally by the combination of; good in tunnel ventilation and lighting leading to clear visibility, mechanised excavation, spoil removal by conveyor, avoidance of the use of lattice girders or reinforcing mesh and, remote application of sprayed concrete by robots. These methods removed many of the safety hazards of open face excavation and in particular avoided the need to work beneath unsupported ground. Access requirements were set such that personnel should never be required access beneath in place sprayed concrete with a UCS of less than 1MPa. The required geological face inspections, which did require close inspection of and access to the face, were therefore carried out from within a protected cage. The presence of faults, causing poor face stability, prevented close to the face inspections required to determine the size of the elephant feet support. This resulted in: a larger universally applicable elephant foot, an inclined face excavation and a 3m personnel exclusion zone at the face. The inherent strength gain requirements ensured that the lining outside the exclusion zone had achieved an adequate and safe strength.

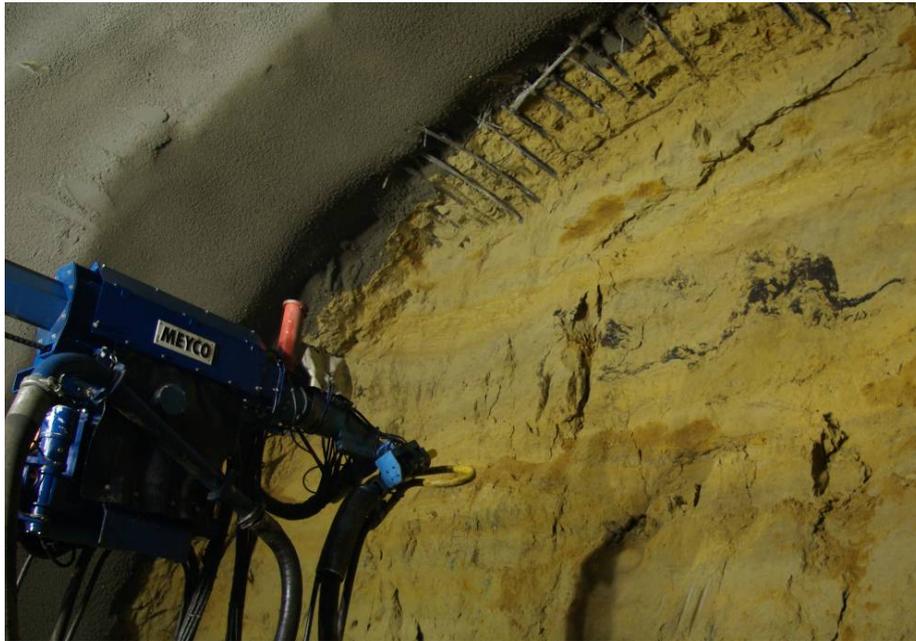
Figure 4 –Typical Spile Installation

4m long GRP spiles were installed at locations of poor ground with open joints, faulting and areas of predicted overbreak. From the many spiling contingency measure options, pre-drilled 32mm solid GRP spiles were widely used and placed in grouted holes in both full arrays and at discrete locations around the tunnel profile. GRP was selected for the spiles to ensure lining durability was maintained. Minimum spiling requirements were specified at the DRMs (e.g. when tunnelling beneath the A3) but additional spiling was specified where required by the tunnel team. A total of 26% of the tunnel required canopy support (canopy tubes or spiles) compared with the initially anticipated 39%.

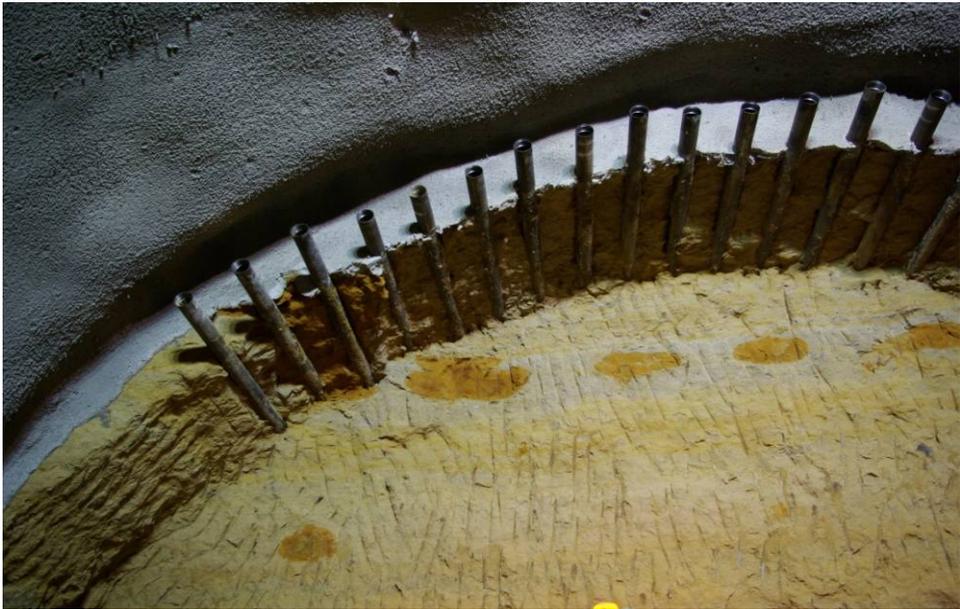
Figure 5 –Typical Canopy Tube Installation

From the south portal the tunnels descended through the UHB/C beds with a high percentage of sand and very weak sandstone requiring support ahead of the face excavation. An additional support type support (Type 7) was developed during construction for this ground location. Type 7 support provided a closed-heading support system where a structural invert was installed in the heading. This allowed the heading to be progressed safely in the sand-dominated material, giving programme savings and safety benefits to the Contractor. Grouting was used initially in conjunction with canopy tubes, however, the grout escaped

through the fissures and locally wetted and weakened the sands around the tubes and it was concluded that the canopy tubes alone provided best support.
