SEQUENTIAL EXCAVATION METHOD TUNNELLING IN WEAK SANDSTONE USING INNOVATIVE METHODS

ABSTRACT: The A3 Hindhead road improvement scheme in Surrey, UK includes 1.8km of twin bore tunnels excavated using the sequential excavation method. This paper describes the design and construction of the tunnels, focusing on the management of risk during construction. Two categories of construction risk are identified: construction project risk and health and safety risk. Systems have been put in place at A3 Hindhead to deal with both of these types of risk and the systems are described. The paper concludes by listing the principle factors in making the project a success, including personnel and design matters.

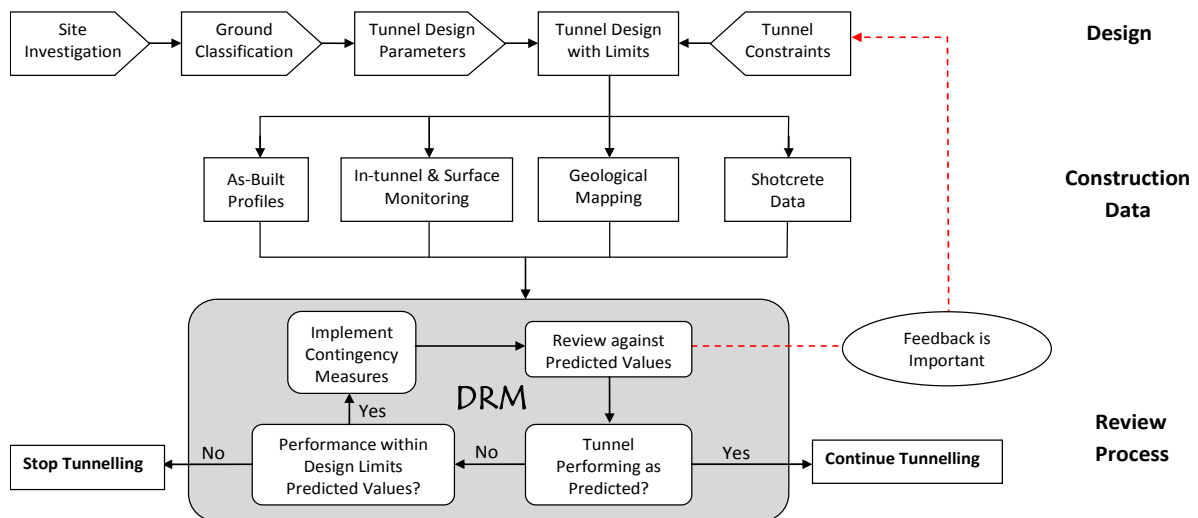
Figure 2 – DRM process map

Management of the construction project risk was achieved through Daily Review Meetings (DRMs) attended by competent and experienced personnel charged with selecting the most appropriate course of construction action going forward. The purpose of the DRM was to check the performance of the constructed tunnel against real time data collected during the previous 24 hrs and trend data. The DRM process is shown schematically in Figure 2. The requirement to hold DRMs was written into the contract specification. Data reviewed included: tunnel settlement and convergence, surface settlement, geological face logs, probing records, early age and 7 & 28 day sprayed concrete strength and quality, environmental monitoring and tunnel inspections.

The product of the DRM was the Required Excavation and Support Sheet (RESS). A RESS was produced daily for each face and was effectively a ‘permit to dig’ (i.e. no excavation was permitted without a valid RESS). Each RESS was signed at the DRM by the Contractor, Designer and an Independent Engineer (as requested by the Contractor to ensure impartiality). This procedure ensured that the contract parties carried out a daily review of the real time data to confirm that the chosen lining type and additional measures adopted were performing correctly and were compatible with current and expected ground conditions.

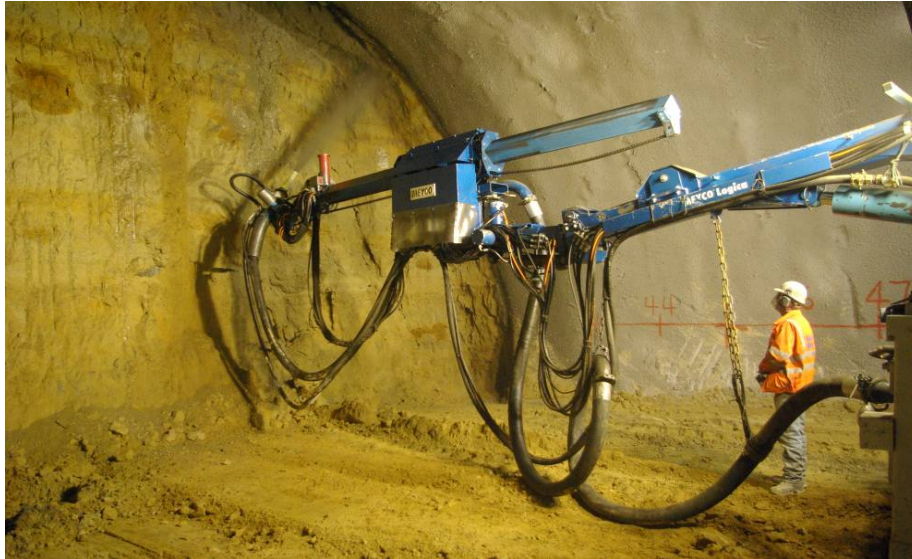
Figure 3 – Primary Lining Application

The risk of injury to personnel within the tunnel was mitigated principally by the combination of; good in tunnel ventilation and lighting leading to clear visibility, mechanised excavation, spoil removal by conveyor, avoidance of the use of lattice girders or reinforcing mesh and, remote application of sprayed concrete by robots. These methods removed many of the safety hazards of open face excavation and in particular avoided the need to work beneath unsupported ground. Access requirements were set such that personnel should never be required access beneath in place sprayed concrete with a UCS of less than 1MPa. The required geological face inspections, which did require close inspection of and access to the face, were therefore carried out from within a protected cage. The presence of faults, causing poor face stability, prevented close to the face inspections required to determine the size of the elephant feet support. This resulted in: a larger universally applicable elephant foot, an inclined face excavation and a 3m personnel exclusion zone at the face. The inherent strength gain requirements ensured that the lining outside the exclusion zone had achieved an adequate and safe strength.

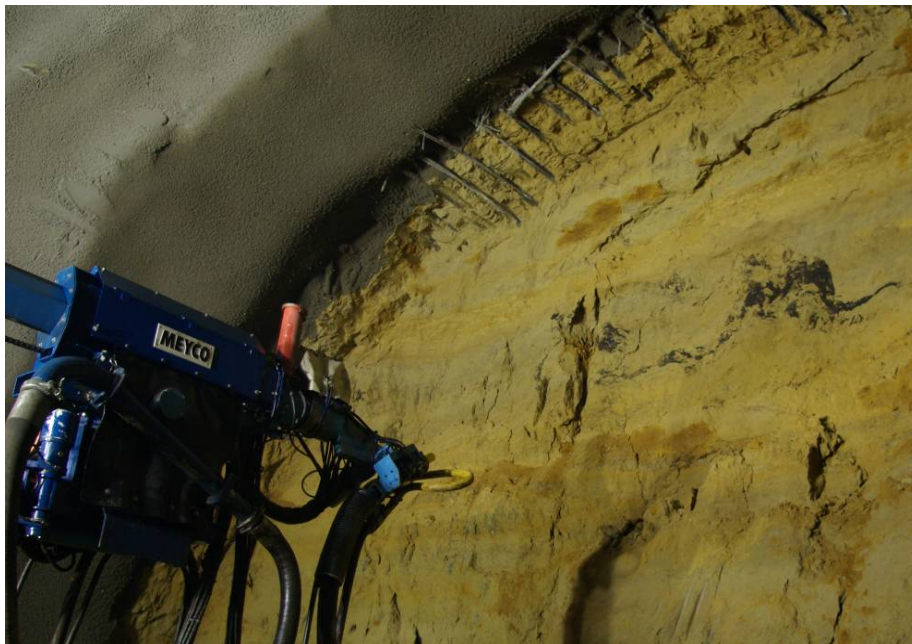
Figure 4 –Typical Spile Installation

4m long GRP spiles were installed at locations of poor ground with open joints, faulting and areas of predicted overbreak. From the many spiling contingency measure options, pre-drilled 32mm solid GRP spiles were widely used and placed in grouted holes in both full arrays and at discrete locations around the tunnel profile. GRP was selected for the spiles to ensure lining durability was maintained. Minimum spiling requirements were specified at the DRMs (e.g. when tunnelling beneath the A3) but additional spiling was specified where required by the tunnel team. A total of 26% of the tunnel required canopy support (canopy tubes or spiles) compared with the initially anticipated 39%.

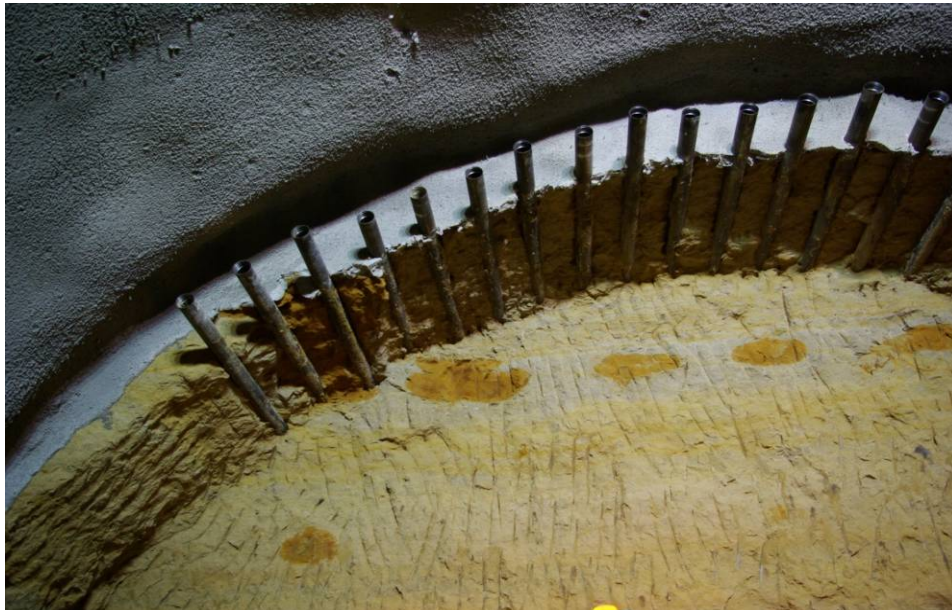
Figure 5 –Typical Canopy Tube Installation

From the south portal the tunnels descended through the UHB/C beds with a high percentage of sand and very weak sandstone requiring support ahead of the face excavation. An additional support type support (Type 7) was developed during construction for this ground location. Type 7 support provided a closed-heading support system where a structural invert was installed in the heading. This allowed the heading to be progressed safely in the sand-dominated material, giving programme savings and safety benefits to the Contractor. Grouting was used initially in conjunction with canopy tubes, however, the grout escaped

through the fissures and locally wetted and weakened the sands around the tubes and it was concluded that the canopy tubes alone provided best support.
